CRAFTSMAN IN DISGUISE

A massive restoration returns a weary “Colonial Revival” to its origins

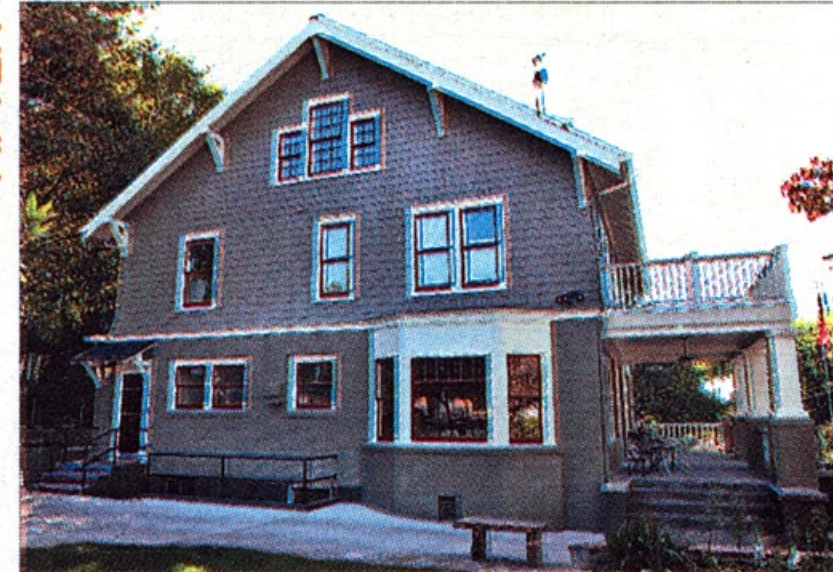
AFTER

An Arts and Crafts porch topped by a second-story balcony replaces an ill-fitting wooden pergola thought to have been added in a 1930s remodel.

Best of all, they rebuilt the front porch with massive brick piers and columns, and put back the second-story balcony and balustrade. They even re-created the custom 4-by-12-inch top rail on the new "old" porch.
